Smoke and Dye Testing Summary

High Level Sewershed

Test ID	Test Type	Date Inspected	Company / Super.	Blower MH	Ground Condition	Notification Made?	Total Length
S1028-288	Smoke	9/9/2009	ADS/TM	S09II1018MH	Dry	Yes	861.74

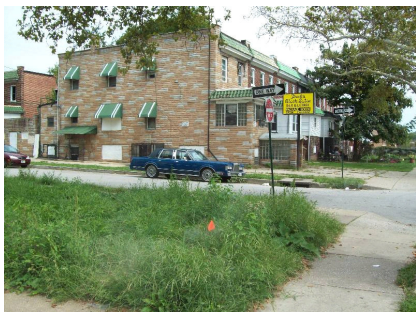
Picture \S1028-288-OB01-P01.jpg

Comments Smoke from sanitary manhole in front yard.
4601 Reisterstown Rd.

Comments Front yard, 4601 Reisterstown Rd.

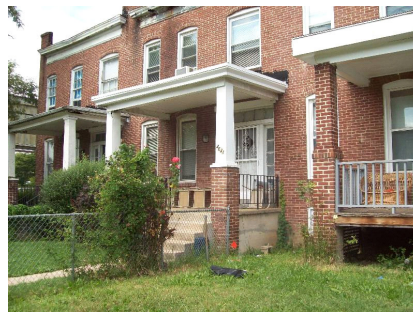
Picture \S1028-288-OB02-P01.jpg

Comments Smoke from cleanout in front yard. 4629
Reisterstown Rd.

Comments Front of house, 4629
Reisterstown Rd.
